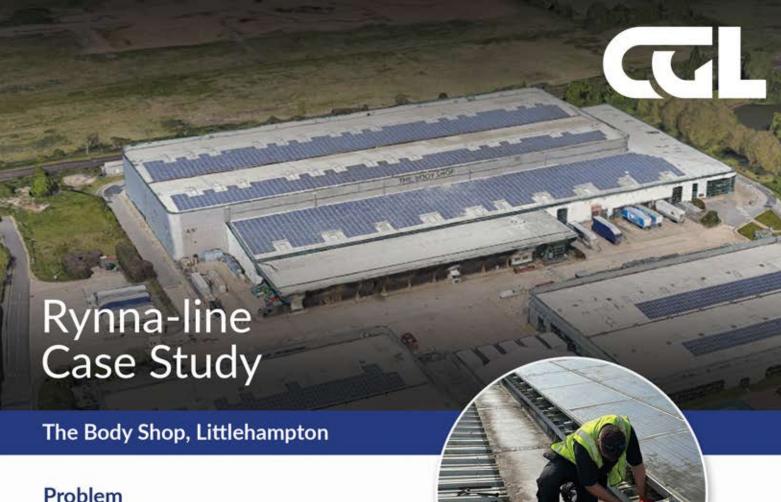
This client reported severe roof & gutter leaks in multiple locations. The stock and internal machinery damage was a repeating issue for our client. Previous remedial work had failed on various occasions. The client appointed a dedicated architectural practice, who worked in partnership with ourselves as the rainwater experts.

The inspected gutters showed signs of a previous repair, with a poorly installed EPDM and Thermoplastic Polyolefin material (TPO). This material had moved excessively and created unnecessary bubbles within the gutter, affecting flow, and the long-term drainage capacity.

Provide additional roof drainage features and remove existing failed remediation product from the gutters. Clean and examine the existing interface details across the roof drainage areas.

Install the made-to-measure Rynna-line system to provide a solid waterproof solution and applicable warranty.
